**SITE ASSESSMENT REPORT
FOR
ORBITRON
DELPHOS, ALLEN COUNTY, OHIO
TDD: T05-9407-003
PAN: EOH1042SAA
DOCUMENT CONTROL NUMBER: TAT-05-23-04023**

AUGUST 15, 1994

Gail Nabasny
Deputy Project Officer
Emergency Support Section
U.S. EPA - Region V

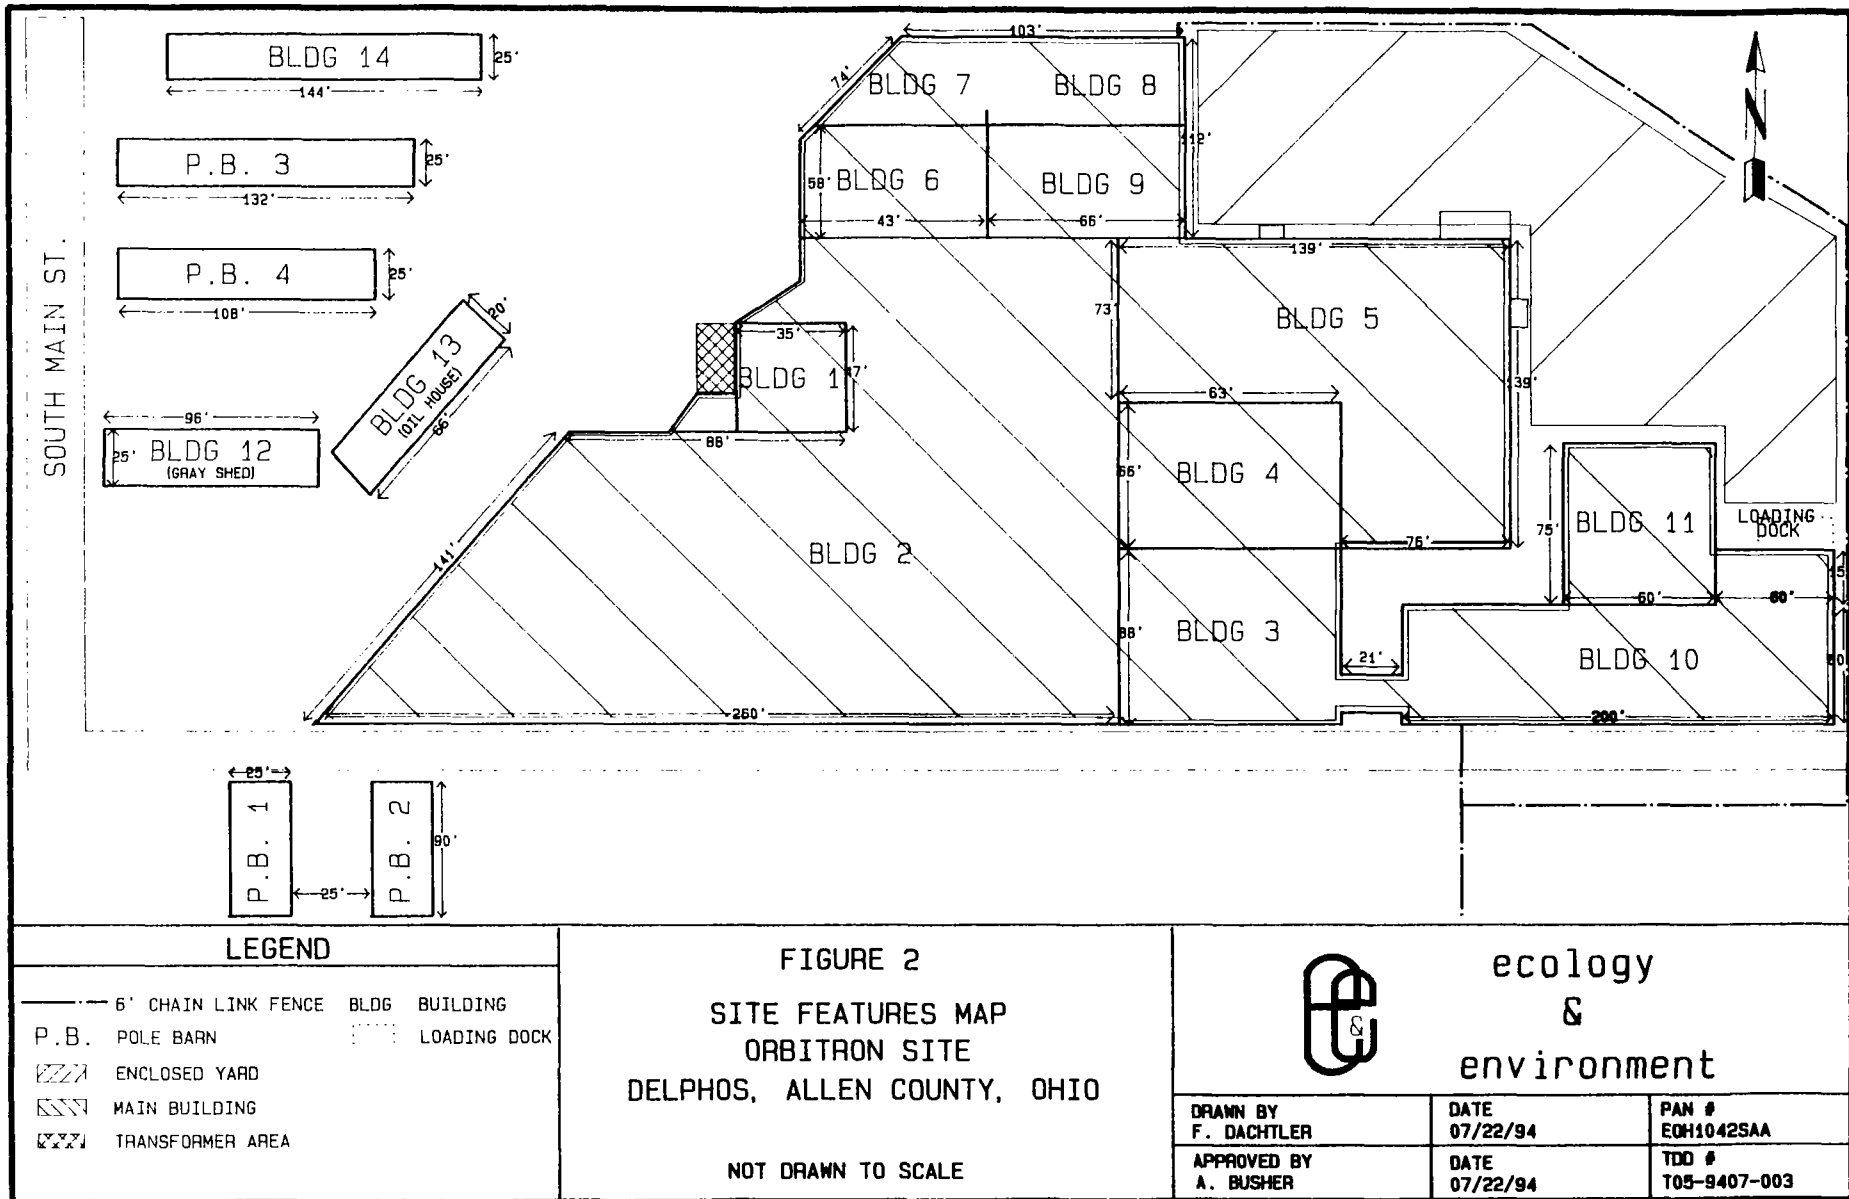
The Orbitron site is located at 901 South Main Street in Delphos, Allen County, Ohio (Figure 1). The site consists of a 100,000 ft² main building, an oil house (building 13) of 1320 ft², sheds of 2400 (building 12) and 3600 ft² (building 14), four pole barns, and a loading dock area (Figure 2). The main building is comprised of eleven smaller buildings (buildings 1-11 on Figure 2) which serve as production areas, tool rooms, and packaging areas as well as office and lounge space. Residences are located 50 feet to the north of the site. Local industries border the facility on the east and south perimeters. South Main Street and a large field border the facility on the west.

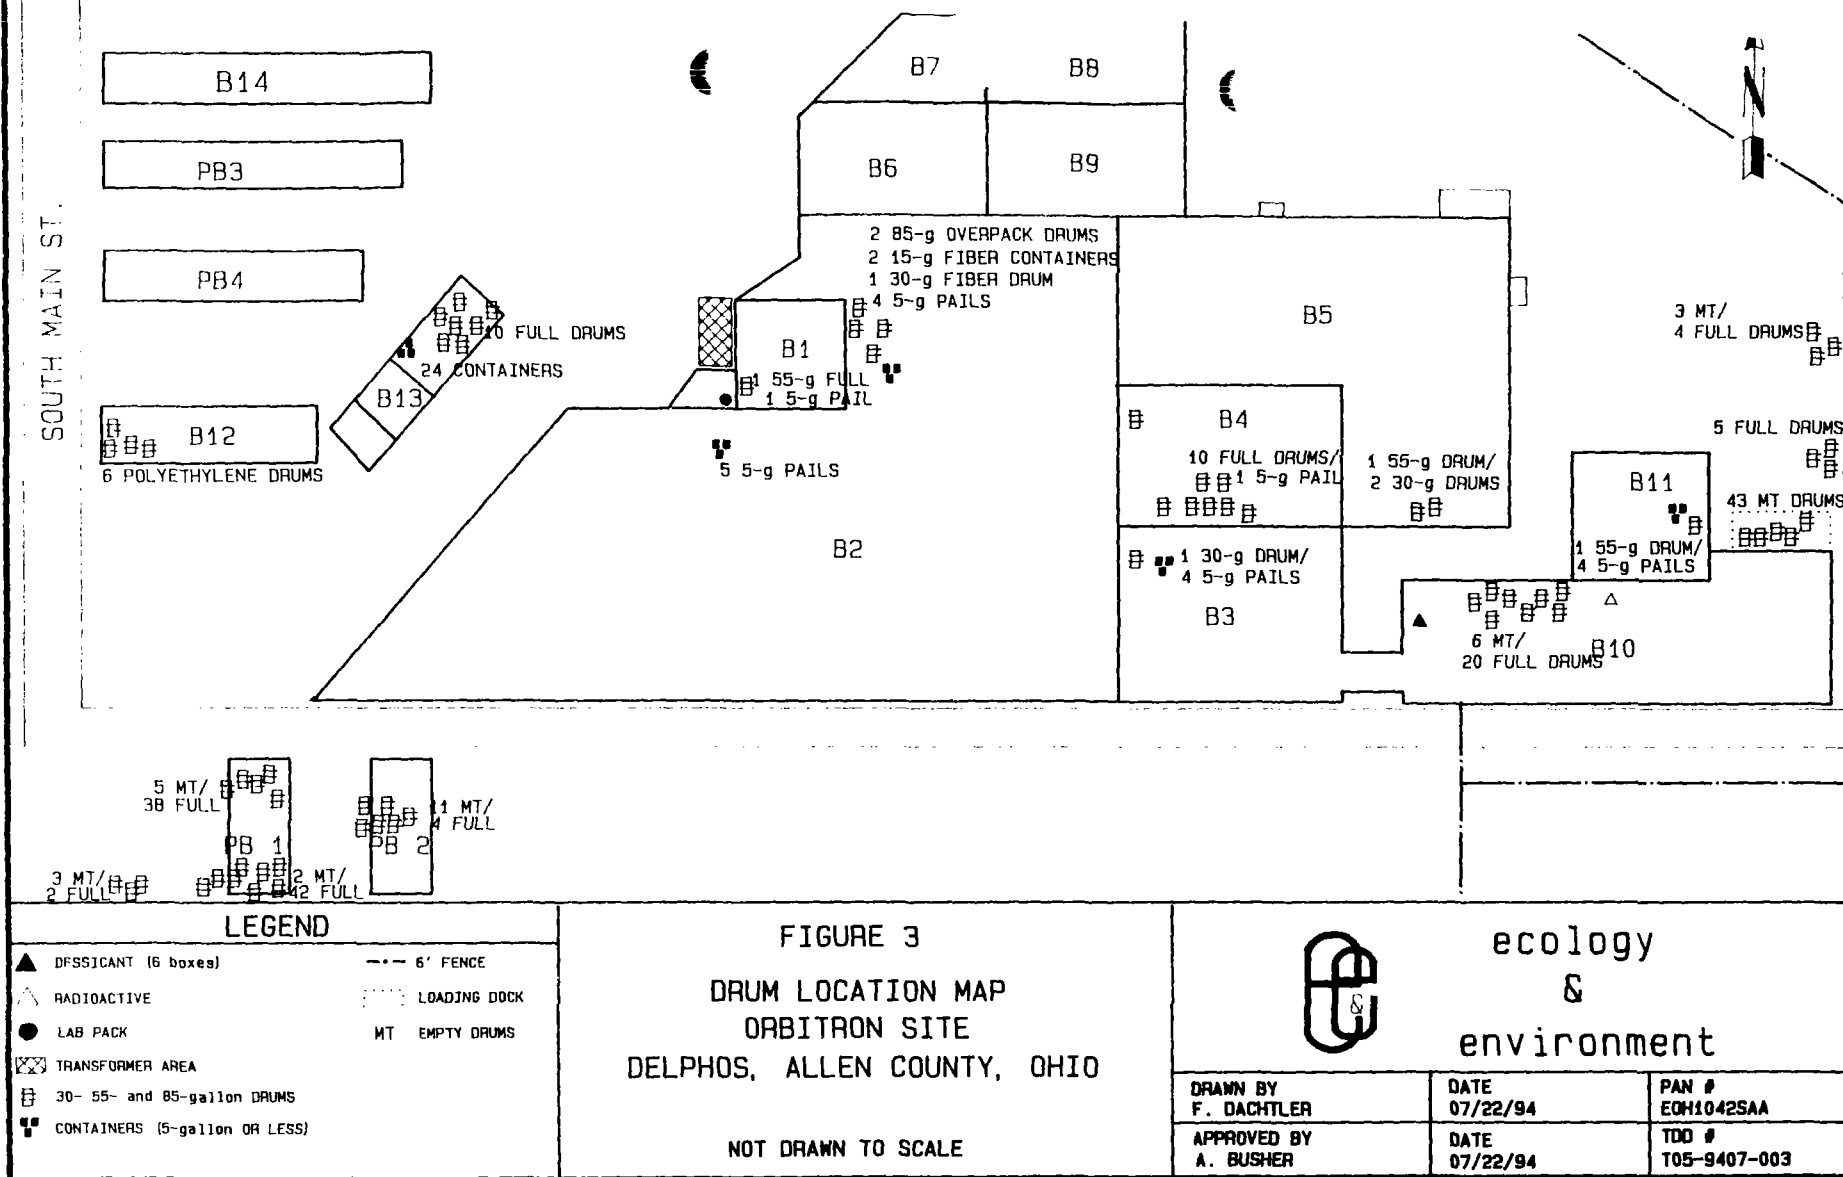
Several 55-gallon drums were observed within the fenced areas, and in the pole barns and shed areas. Approximately two hundred full and one hundred and ten empty drums and containers were observed throughout the site. Drums in several areas of the building were observed to be leaking and/or bulging. Drum labels indicated the presence of incompatible materials in close proximity to each other. Acid containing drums were near base drums, and xylene containing materials near oxidizers. Figure 3 indicates approximate locations of drums and containers.

Pole barns: Four pole barns were located on-site. Pole barn 1 (PB1) contained approximately eighty-two full and 10 empty 55-gallon drums in 3 separate clusters (Figure 3). In the area

surrounding the location of the June 2, 1994, spill which was investigated by the Delphos FD. Four 85-gallon overpacks and five 55-gallon steel 17-H drums containing the contaminated soil and debris from the spill were among the drums inventoried at this location. The drums were stacked and were unstable. The area to the south of PB1 was cluttered with wood and metal debris, pieces of poly product, and heavy brush. Labels indicated the presence of: isopropyl alcohol, UN 1219; methylethyl ketone (MEK); roof coatings; and other materials labelled "FLAMMABLE". Hand written markings also indicated the presence of used MEK.
